**Engine Failure  
Analysis Manual**

# **STIHL ENGINE FAILURE ANALYSIS MANUAL**

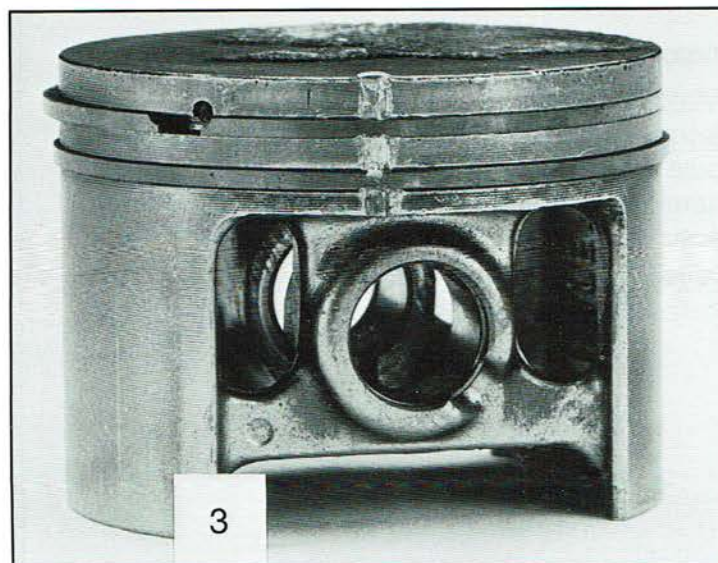
Photo No. 3

Subject: **TRANSFER PORT OF PISTON**

Observation: Piston ported engine, deep score from top edge to piston pin boss.

Cause: Lower con rod bearing and/or cage damaged. RPM's above recommended top end. Leads to excessive load on the components, causing lubrication breakdown.

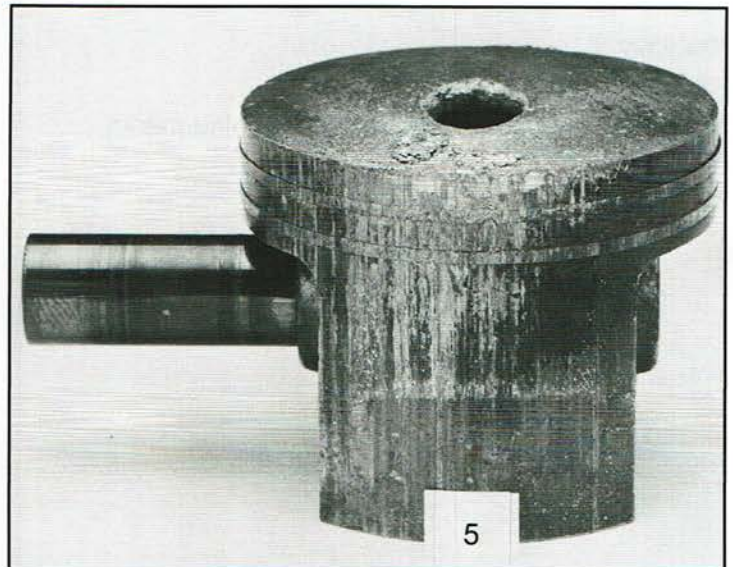
Photo No. 5

Subject: **PISTON**

Observation: Piston has a lean seizure. Piston top has a hole as if burned by a torch.

Cause: Severe lean seizure.

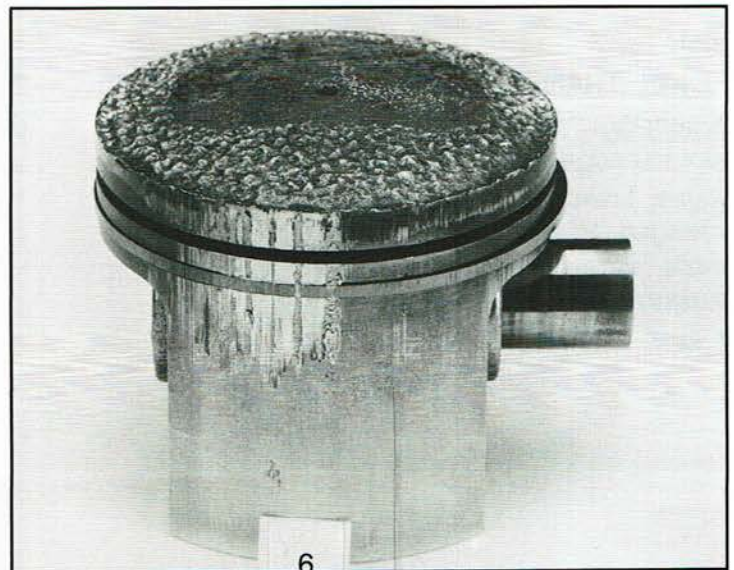
Photo No. 6

Subject: **PISTON**

Observation: Indentations on the piston dome could be perceived as detonation marks. Examination of the cylinder photo No. 39 shows debris was caught in combustion chamber.

Cause: Foreign object has gone through engine. Sharp edges have lead to pre-ignition and seizure.

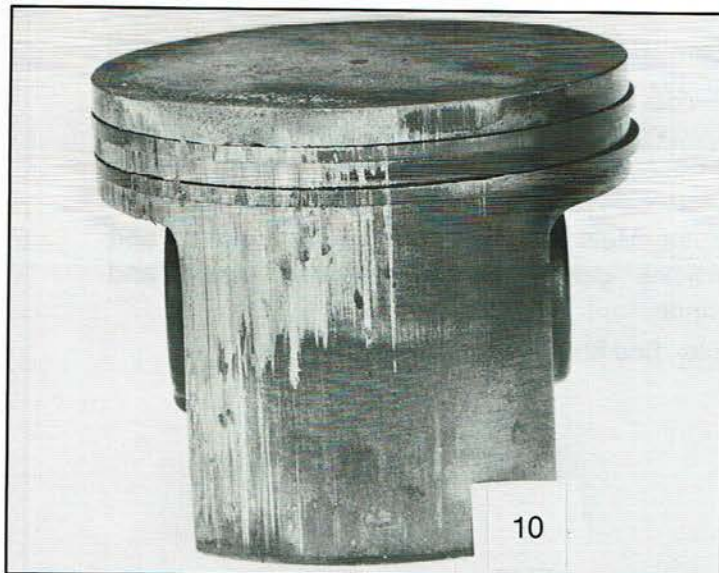
Photo No. 10

Subject: **PISTON**

Observation: Lean seizure.

Cause: Among the possibilities are wrong carburetor settings, stiff carburetor diaphragms, clogged fuel filters, stale gas, alcohol in fuel, air leaks, incorrect ignition timing, part throttle operation, modified mufflers. Note photo 11.

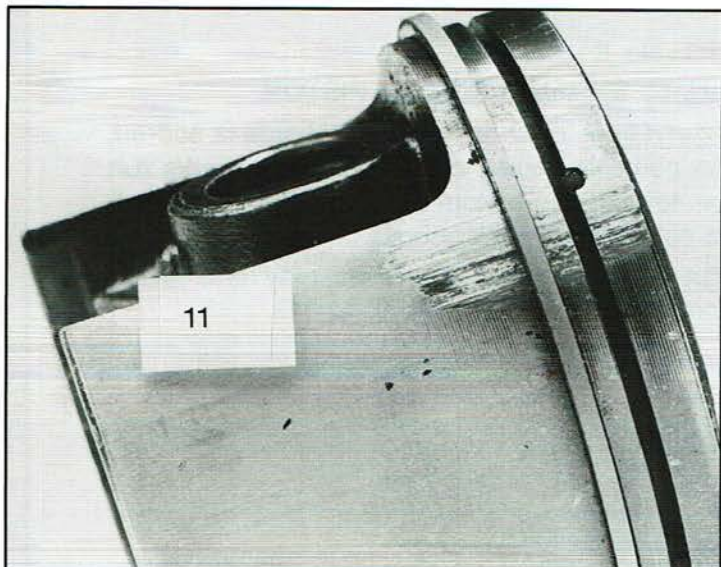
Photo No. 11

Subject: **PISTON**

Observation: Lean seizure.

Cause: This seizure is opposite of the heavy exhaust score and was crowded or pushed by the expanding exhaust side of the piston.

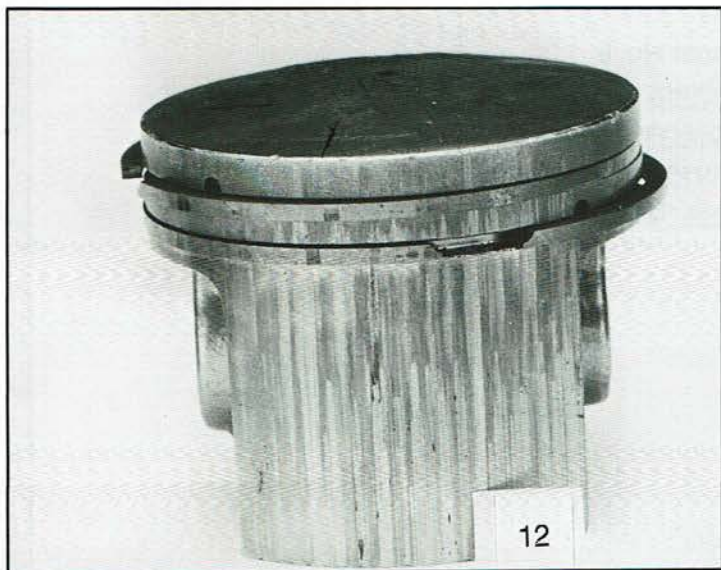
Photo No. 12

Subject: **PISTON INTAKE**

Observation: Piston is scored from the rings down.

Cause: This type of score has two different causes. One is called a snow or water score. The lubricant has been washed off the piston skirt. Occurs in snow or very humid conditions. The second type is alcohol or either score. Effect is the same.

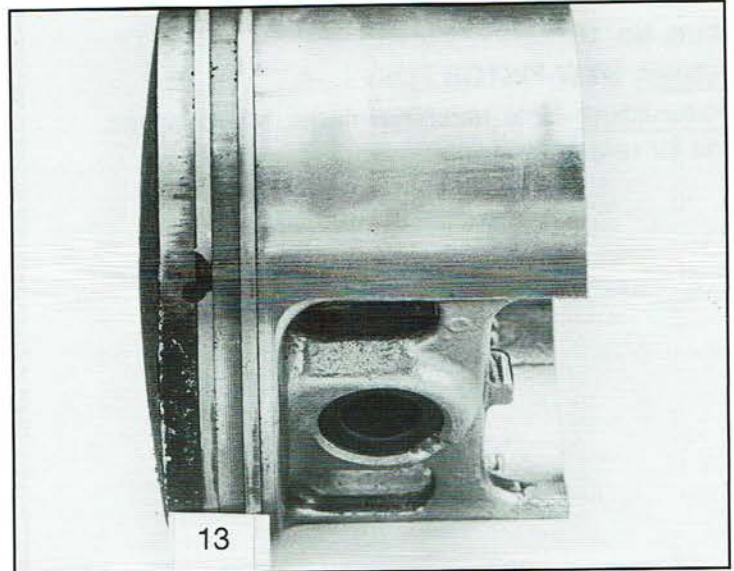
Photo No. 13

Subject: **PISTON INTAKE SKIRT**

Observation: Deposits on the piston dome, burnished piston skirt, build up of carbon-like deposits in the ring landings. Rings show beginning of clipping condition. Intake skirt is highly polished.

Cause: Combination of ingested fine dirt, fuel and oil mix build up in the ring grooves inhibiting the ring movement.

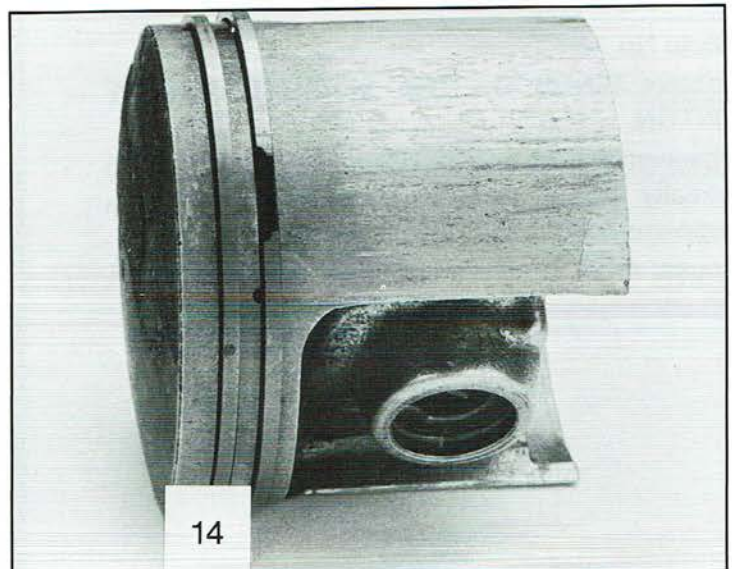
Photo No. 14

Subject: **INTAKE SKIRT OF PISTON**

Observation: Skirt has been ground and scored.

Cause: Dirt and grit ingested into the engine. Note photo 41 for the cylinder damage.

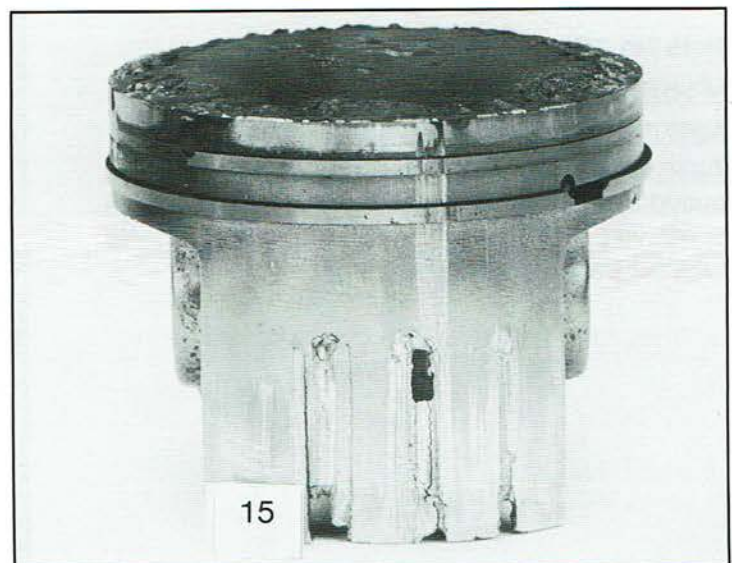
Photo No. 15

Subject: **INTAKE SIDE OF PISTON**

Observation: Deep scores, broken skirt, marks in the dome of piston.

Cause: Foreign debris caught between intake port and the piston skirt.

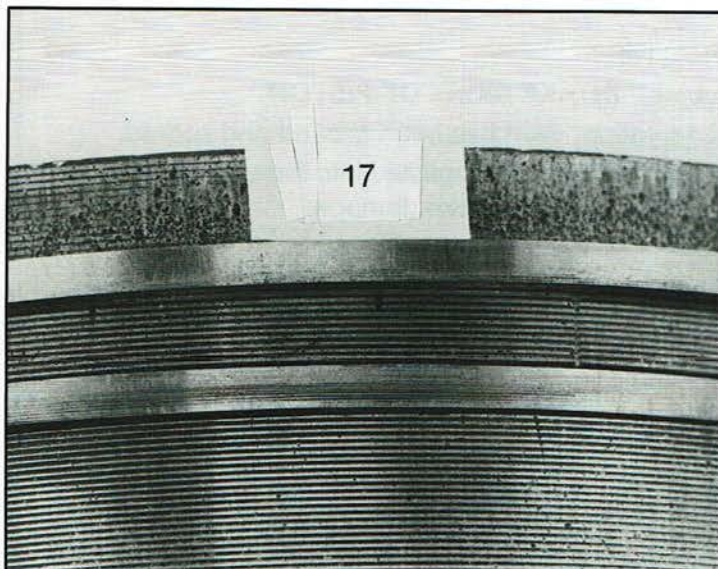
Photo No. 17

Subject: **RINGS ON THE EXHAUST SIDE OF PISTON**

Observation: Top ring almost broken in, bottom ring partially broken in, area above top ring has a peppered look.

Cause: Ring wear is normal, top ring seats first, dirt particles can cause a peppered effect.

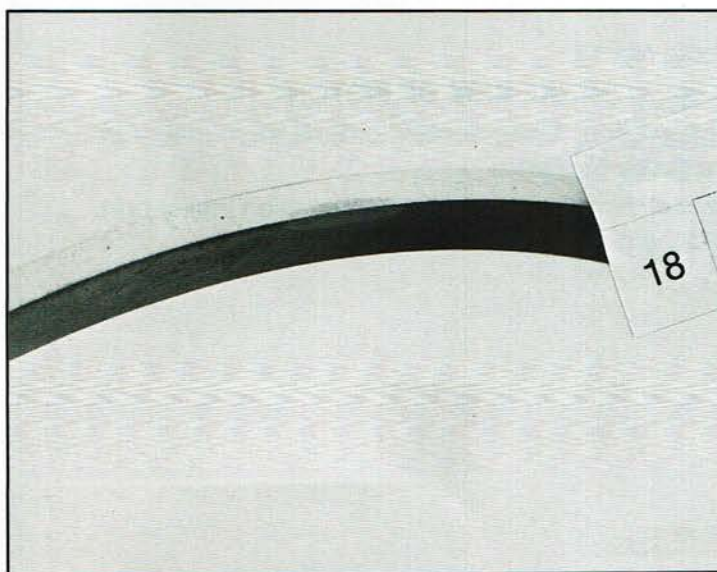
Photo No. 18

Subject: **PISTON RING**

Observation: Sharp edge on the ring is burnished.

Cause: This is the first sign of ring clipping. This is caused by over revving the engine. Because of the excessive piston speed the rings do not have time to retract into their grooves.

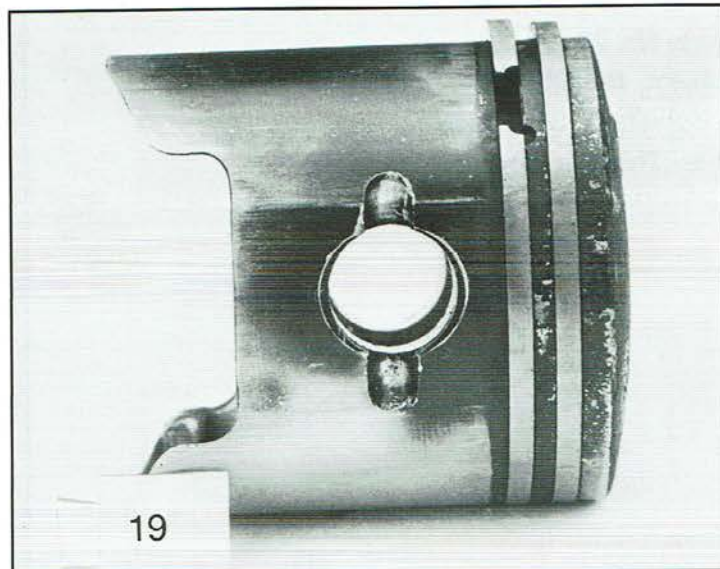
Photo No. 19

Subject: **PISTON**

Observation: Heavy build up on top and sides of piston, partial ring sticking.

Cause: Improper fuel/oil mix or ratio. These symptoms are also related to improper RPM operations. Example half throttle running.

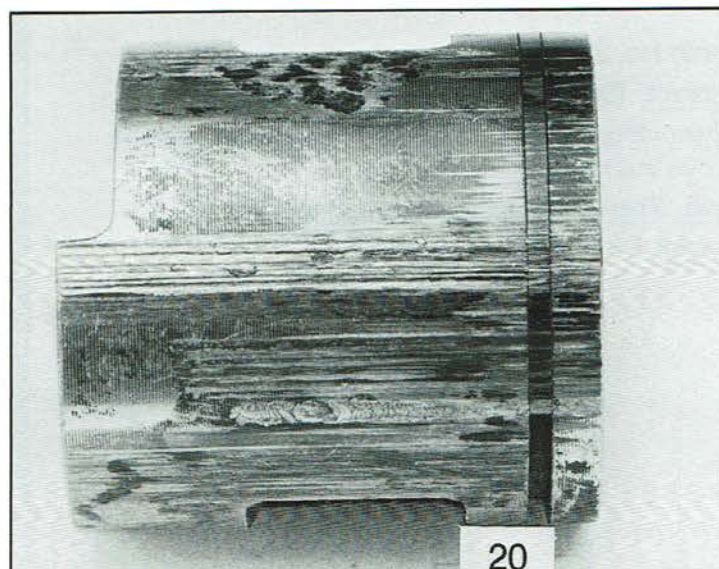
Photo No. 20

Subject: **PISTON**

Observation: Piston scored over most of surface from the top to the bottom, dark discoloration in and around the score.

Note: This piston is from a long stroke, reed plate, induction type engine.

Cause: This is lean seizure.

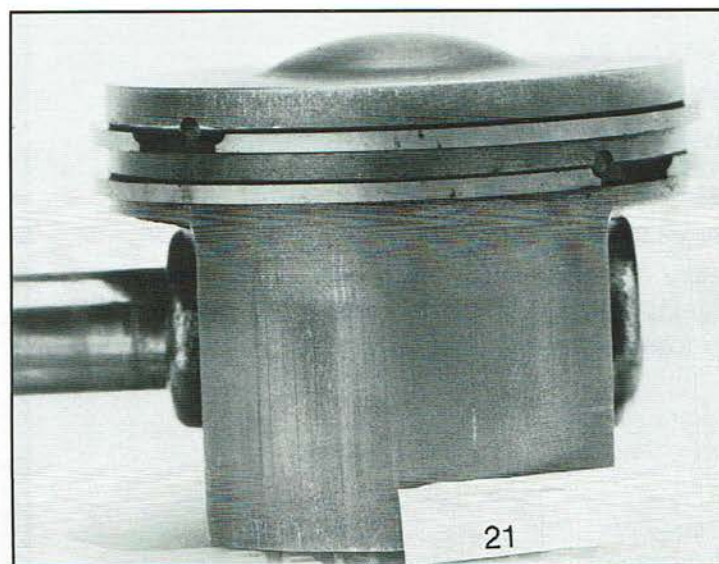
Photo No. 21

Subject: **INTAKE SKIRT OF THE PISTON**

Observation: Intake skirt has tiny scratches and a sandblasted look. Some of the machine marks are still visible. Piston in service only a short period of time.

Cause: Dirt ingested into the engine. Piston is from an actual test engine.

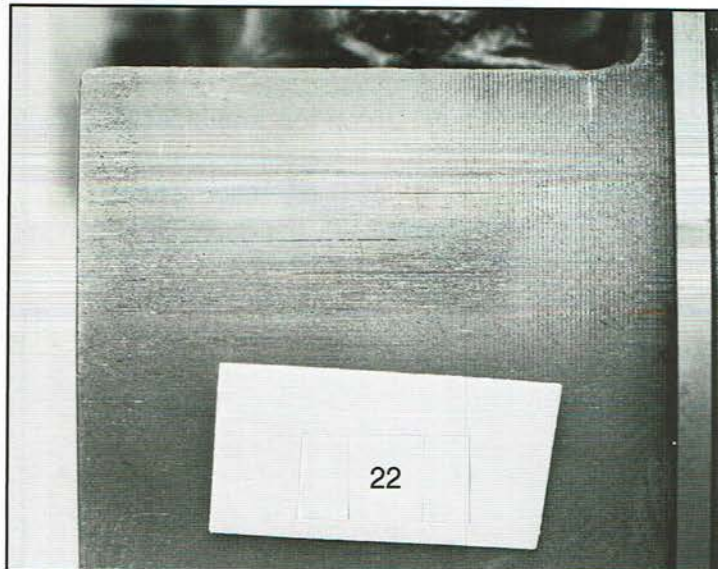
Photo No. 22

Subject: **INTAKE SIDE OF THE PISTON**

Observation: See photo No. 21.

Note: This is a close up of photo 21.

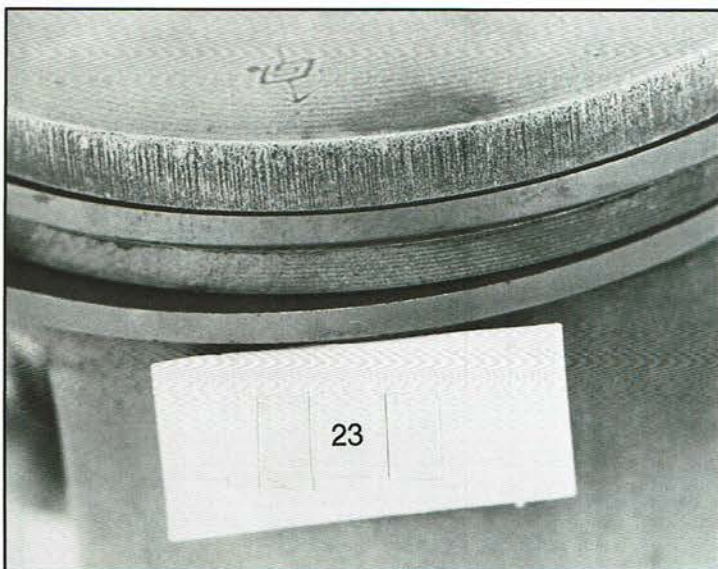
Photo No. 23

Subject: **EXHAUST SIDE OF THE PISTON**

Observation: Pitted and scratched piston surface above the rings.

Note: The wear on the piston rings.

Cause: Dirt in the exhaust flow.

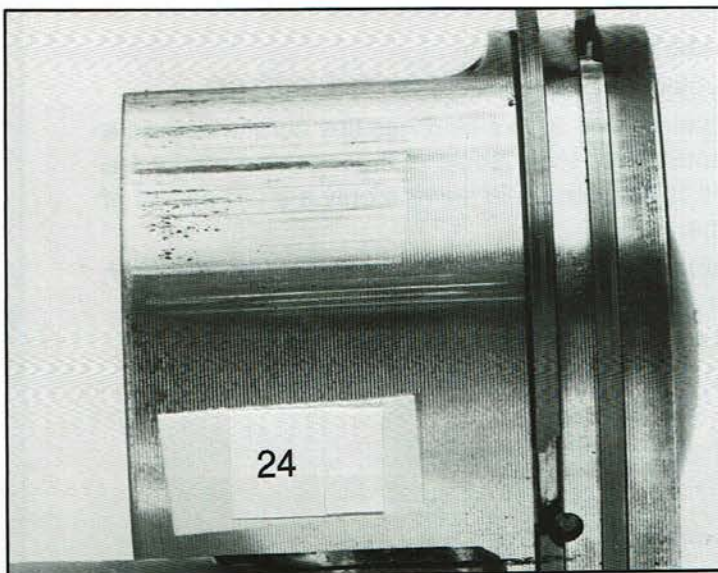
Photo No. 24

Subject: **INTAKE SIDE OF THE PISTON**

Observation: Score marks are primarily below the rings to the bottom of the skirt. On the flywheel side of the skirt they are found across the entire face of the piston.

Cause: Snow/water score. A pre-heater kit would prevent icing conditions. Wet (water score) air filter. Dry filter before use. Alcohol or ether in gas.

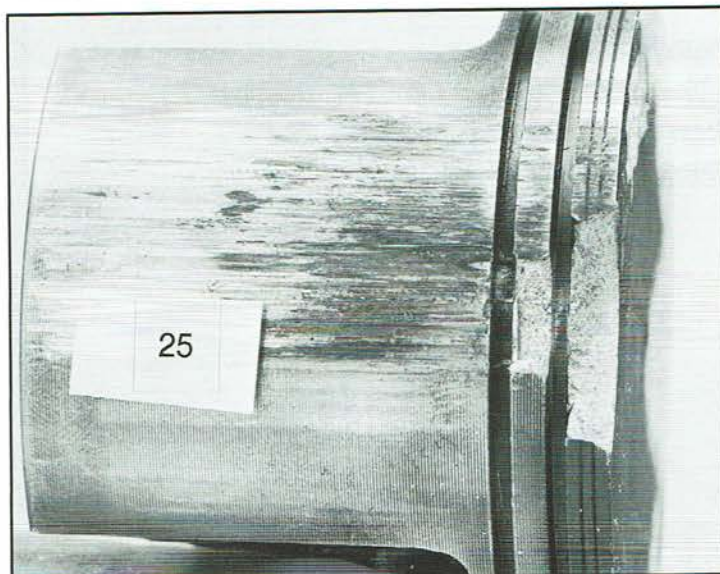
Photo No. 25

**Subject:** EXHAUST SIDE OF PISTON

**Observation:** Piston is broken from the upper edge down to bottom ring. This is different from photo 4.

**Cause:** Saw was run lean, rings got too tight in grooves and clipped the port. Rings have been caught on bottom edge of exhaust port, broken on the down stroke. Check engine for over revving.

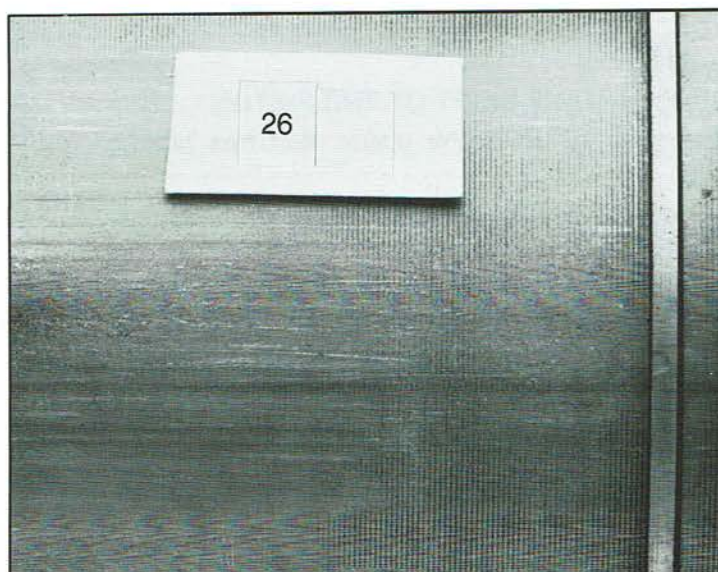
Photo No. 26

**Subject:** INTAKE SKIRT OF THE PISTON

**Observation:** Piston surface worn, various patterns and shades.

**Cause:** Dirt ingested into the engine. Different types of dirt will cause different score patterns. Dirty, worn or wrong application air filter will change scoring patterns on piston.

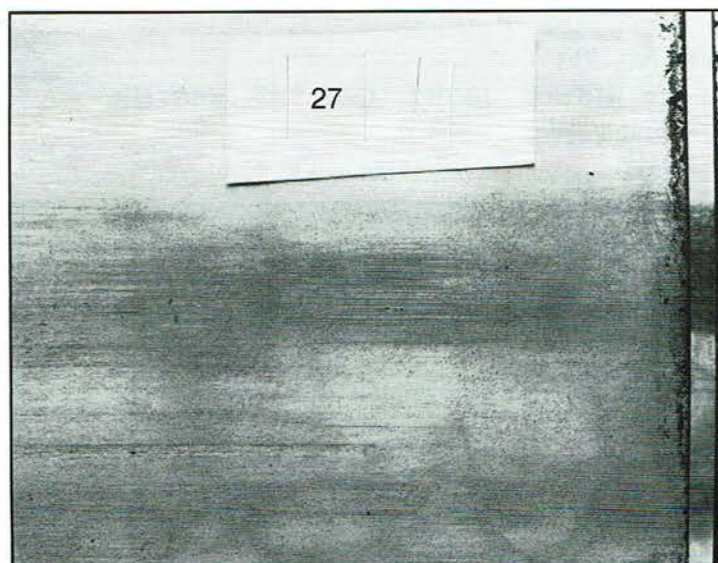
Photo No. 27

**Subject:** INTAKE SKIRT OF THE PISTON

**Observation:** Same as photo No. 26.

**Cause:** Same as photo No. 26.

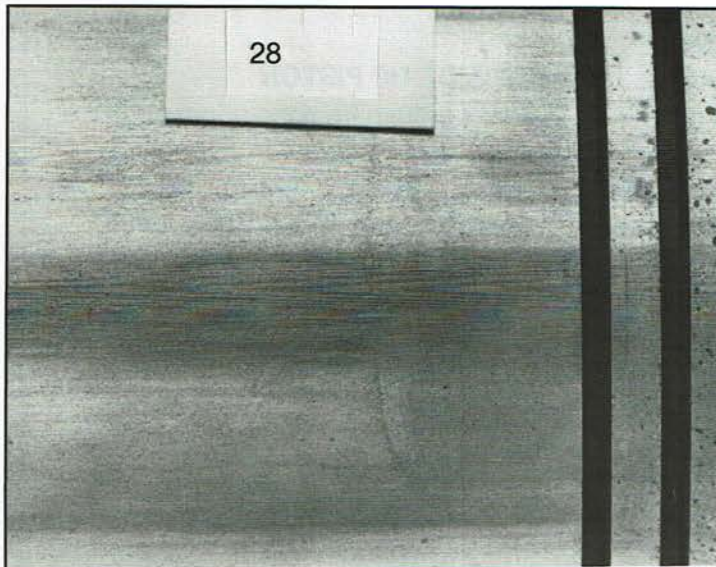
Photo No. 28

Subject: **INTAKE SKIRT OF THE PISTON**

Observation: Same as photo No. 26.

Cause: Same as No. 26.

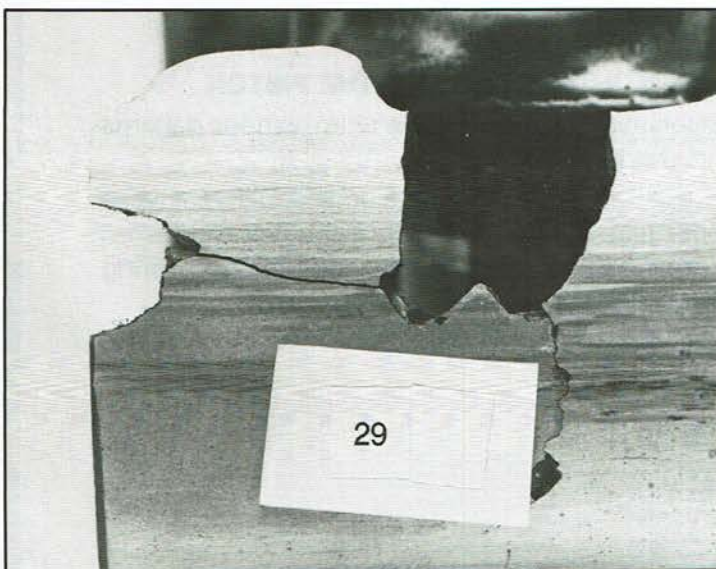
Photo No. 29

Subject: **INTAKE SKIRT OF THE PISTON**

Observation: Part of the piston skirt has broken away.

Cause: The intake skirt has been worn thin by abrasive dirt ingested into the engine. When the tolerances got too big the piston began to slap itself against the cylinder wall until it broke up.

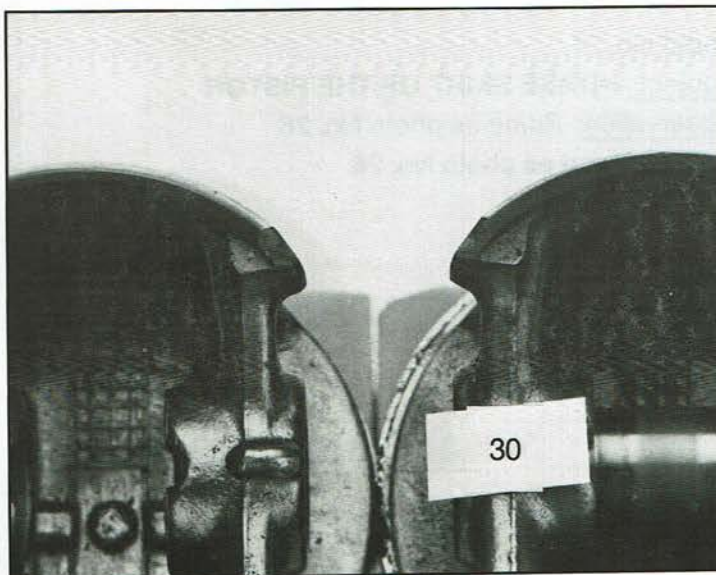
Photo No. 30

Subject: **INTAKE SKIRT OF THE PISTON. BOTTOM VIEW.**

Observation: The intake skirts are at the top of the picture. The piston skirt on the right is much thinner than the skirt on the left.

Cause: Dirt ingested into the engine. Dirt is an abrasive and wears down the surfaces it comes in contact with.

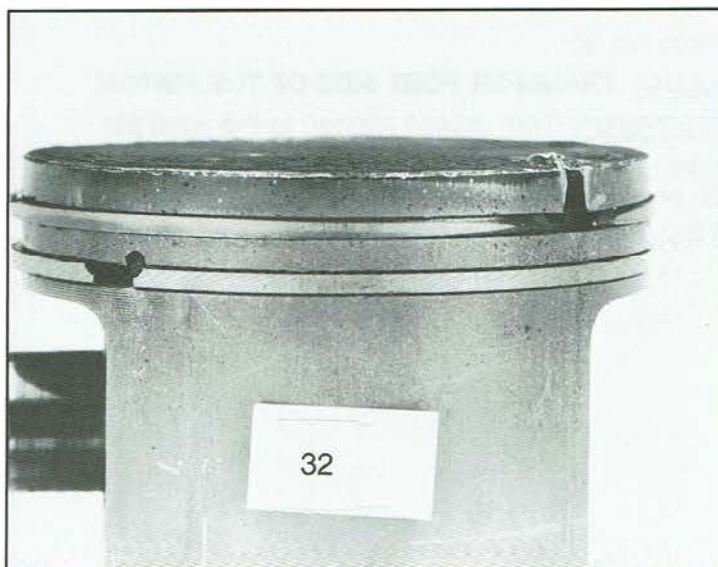
Photo No. 32

Subject: **PISTON LOCATING PIN FOR RINGS**

Observation: Top locating pin has been hammered through the top of the piston.

Cause: Over revving the engine. Ring was jammed into the ring groove when the ring passes the port. The ring end hammers on the locating pin.

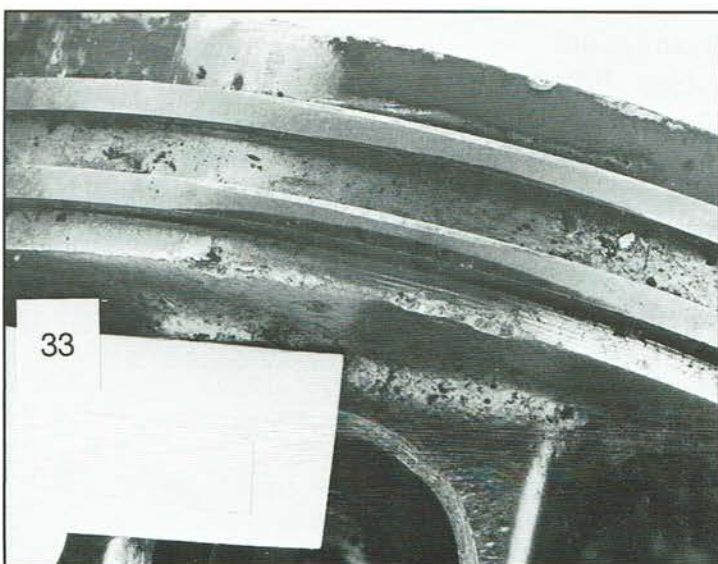
Photo No. 33

Subject: **PISTON RINGS**

Observation: Edges of the rings are worn excessively. See photos 16, 18.

Cause: Over revving of the engine.  
See photos 16, 18.

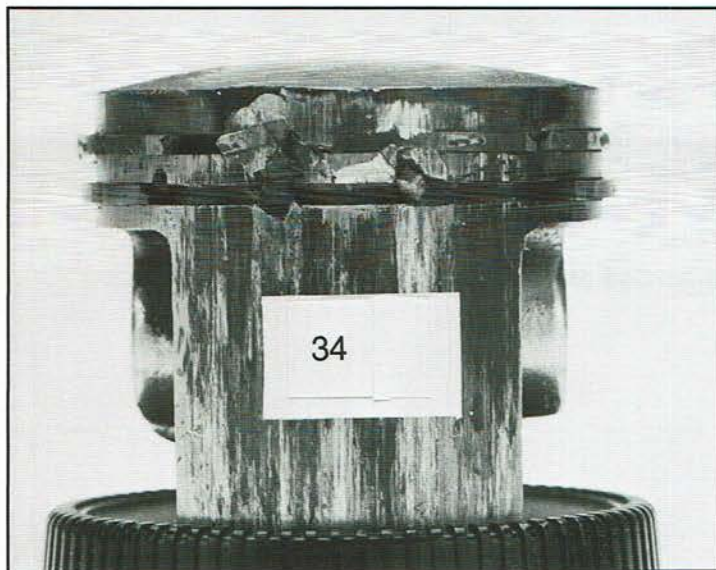
Photo No. 34

Subject: **PISTON**

Observation: Rings and ring landings are broken up. Similar to photo No. 25 but locating pins are intact.

Cause: Piston was installed backwards.

Note: Arrow on piston top always points to exhaust port.

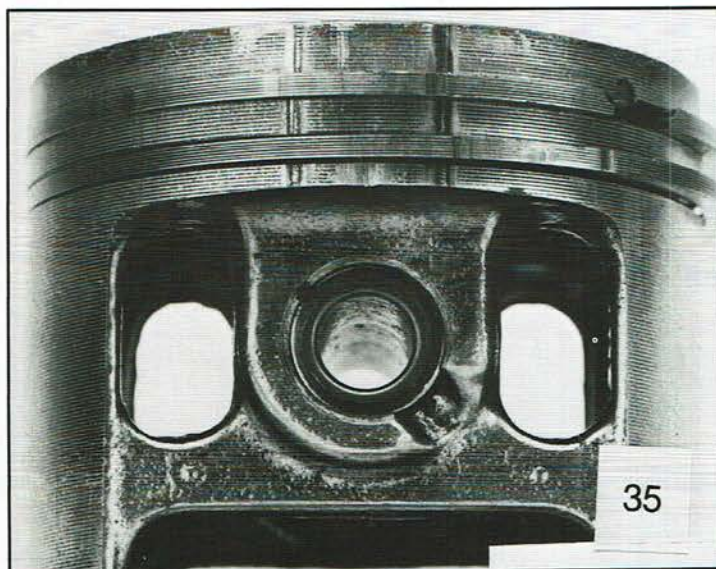
Photo No. 35

Subject: **TRANSFER PORT SIDE OF THE PISTON**

Observation: Twin scores aligned to the wrist pin.

Cause: Wrist pin keeper has come out of piston pin or was not installed. Related damage may be at the bridge of the transfer port.

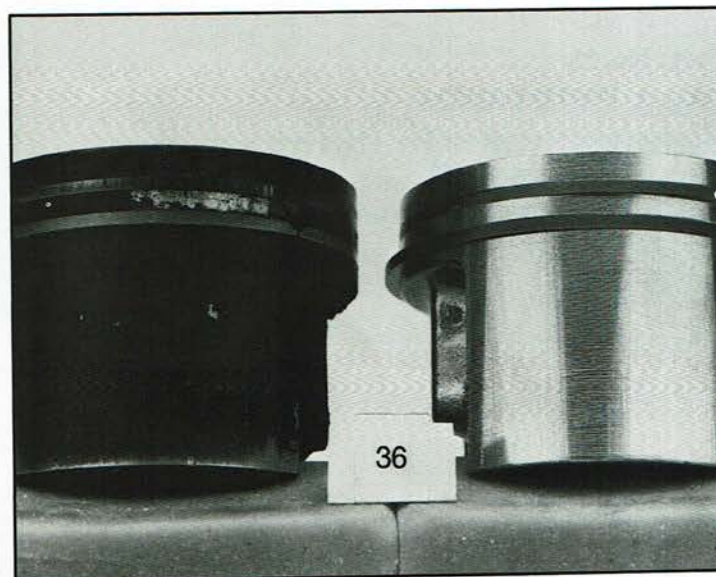
Photo No. 36

Subject: **PISTON**

Observation: Piston on the right is new, piston on the left is coated with a sticky, wax-like varnish.

Cause: Something has been added to the fuel. Possibly bar oil was used as engine oil, or some other unburnable substance.

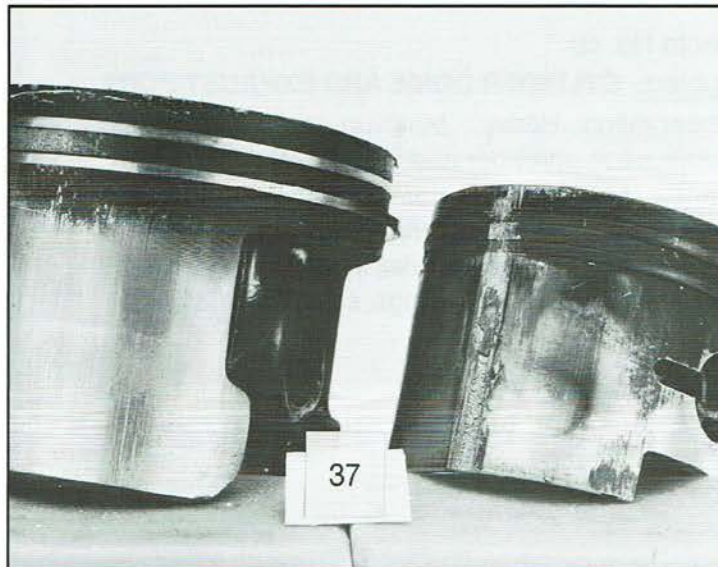
Photo No. 37

Subject: **PISTON RING AND PISTON SKIRT**

Observation: Varnish and gum build up in and around the ring area.

Cause: Improper fuel/mixture or incorrect mixing ratio.

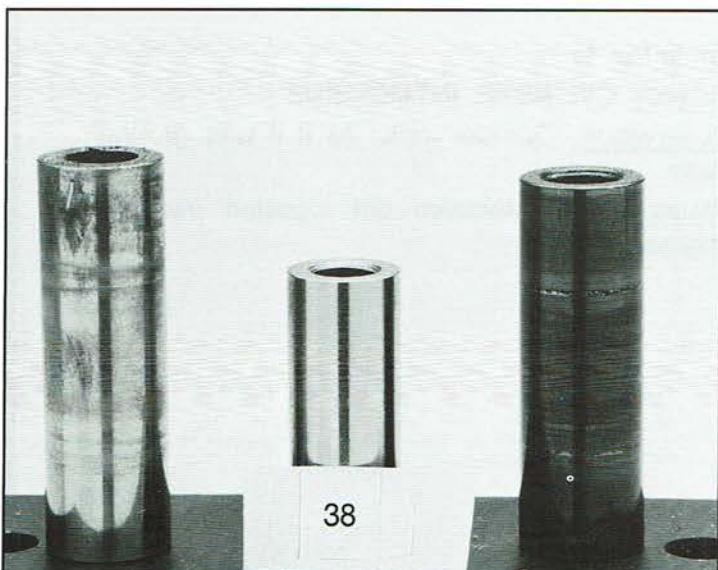
Photo No. 38

Subject: **PISTON PINS**

Observation: Pin on the right is discolored by extreme heat. Pin in the middle is new. The pin on the left is worn.

Cause: Pin on the right, the engine has been over revving and this has caused the lubricating oil to breakdown. Pin on the left is worn from abrasive dirt ingested into the engine.

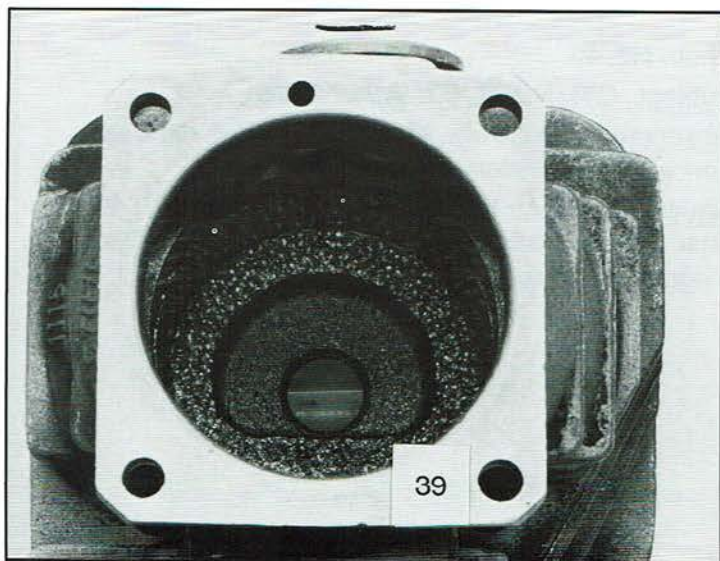
Photo No. 39

Subject: **CYLINDER**

Observation: Indentations on the top of the combustion area.

Cause: Foreign debris has gone through the engine. See photo No. 6.

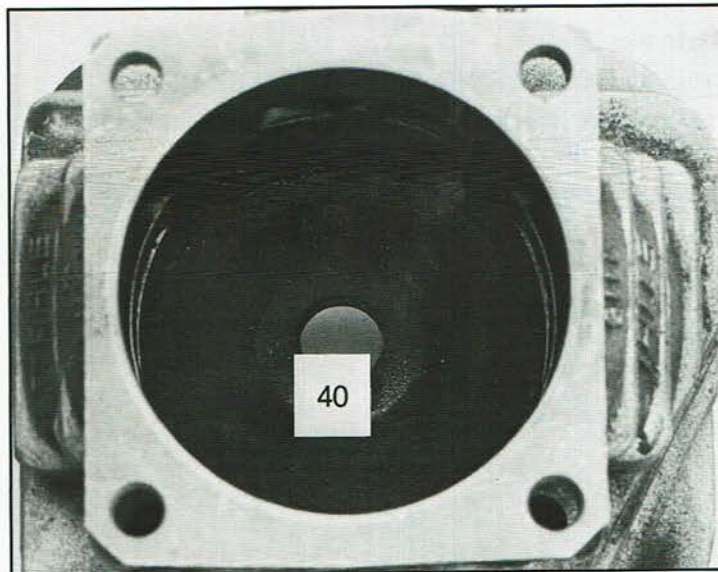
Photo No. 40

Subject: **CYLINDER DOME AND EXHAUST PORT**

Observation: Heavy build-up of carbon in combustion chamber and in exhaust ports.

Cause: Any one or a combination of incomplete burn of fuel/oil mix, incorrect engine mix oil, choke malfunction, clogged air filter, incorrect fuel/oil ratio improper carburetor settings, see photos 31, 42.

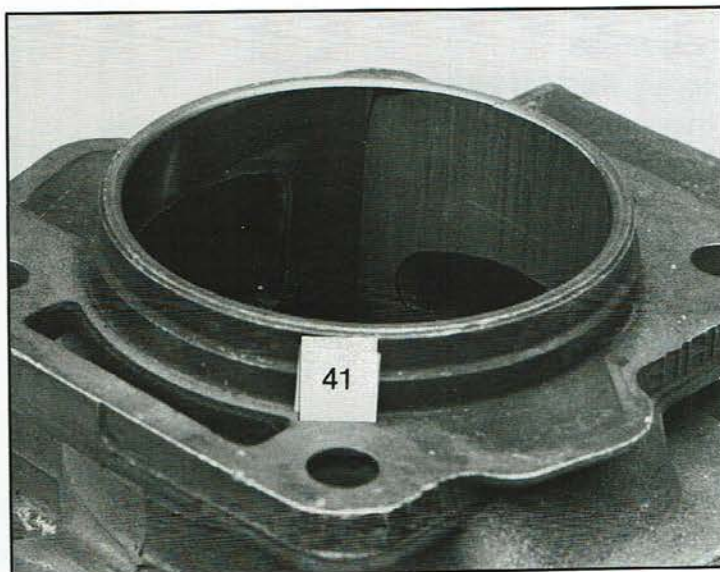
Photo No. 41

Subject: **CYLINDER, INTAKE SIDE**

Observation: Cylinder looks as if it was ground away.

Cause: Severe abrasive dirt ingested into the engine.

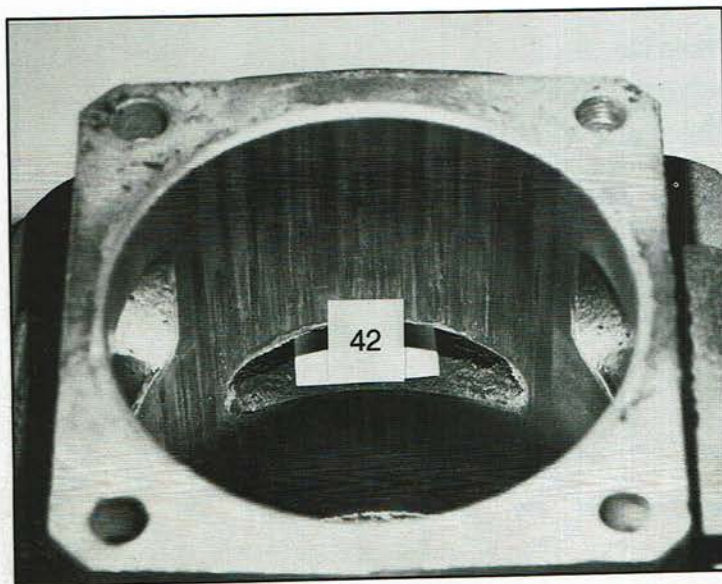
Photo No. 42

Subject: **CYLINDER, EXHAUST SIDE**

Observation: Build-up of carbon in the exhaust port and combustion chamber.

Cause: Incorrect fuel/oil mix, incorrect fuel/oil ratio, incorrect carburetor settings, clogged air filter, clogged fire screen.

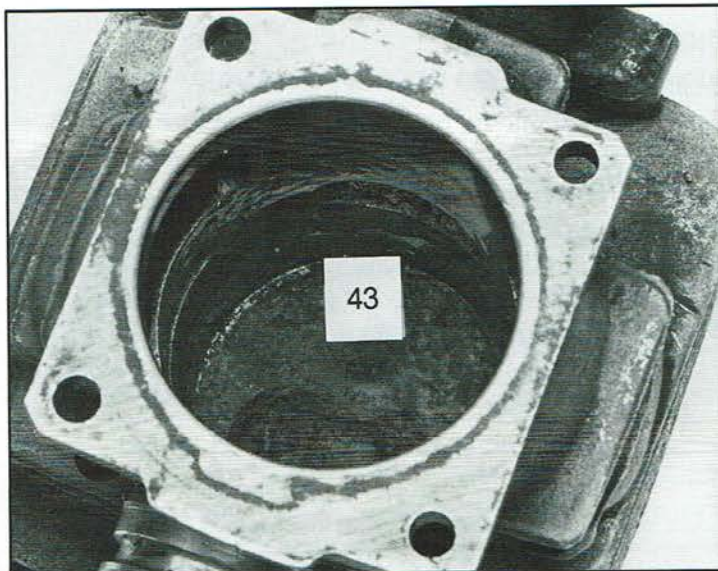
Photo No. 43

Subject: **CYLINDER**

Observation: Chrome in cylinder is flaking off and under layer of whitish colored powder.

Cause: Moisture in the form of water has caused this damage. See also photo No. 67.

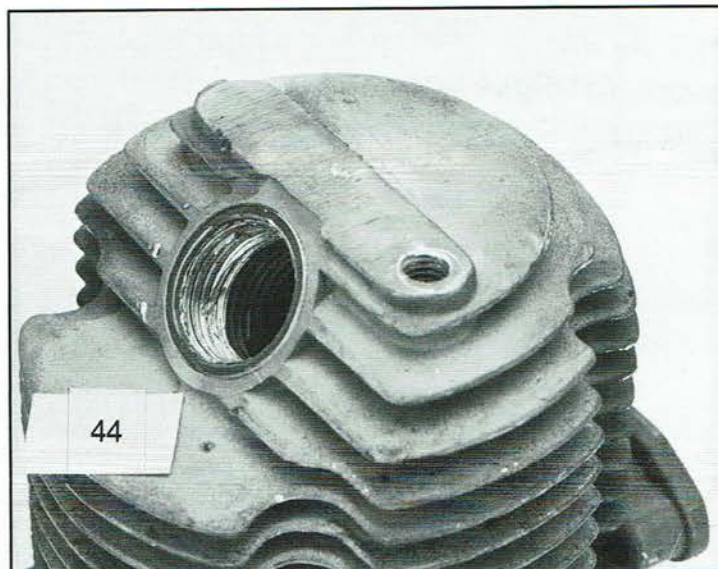
Photo No. 44

Subject: **NEW CYLINDER - SPARK PLUG THREADS**

Observation: Threads are stripped the length of the plug.

Cause: Plug was installed incorrectly with an air wrench.

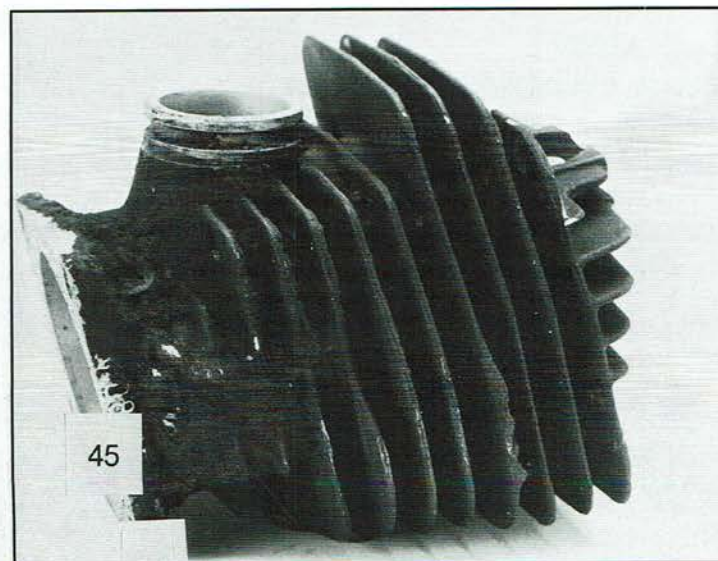
Photo No. 45

Subject: **CYLINDER COOLING FINS**

Observation: Cooling fins are clogged with a build-up of tree sap and sawdust. Saw is developing heat related problems.

Cause: Poor operator maintenance, saw should be checked and cleaned if necessary once a week.

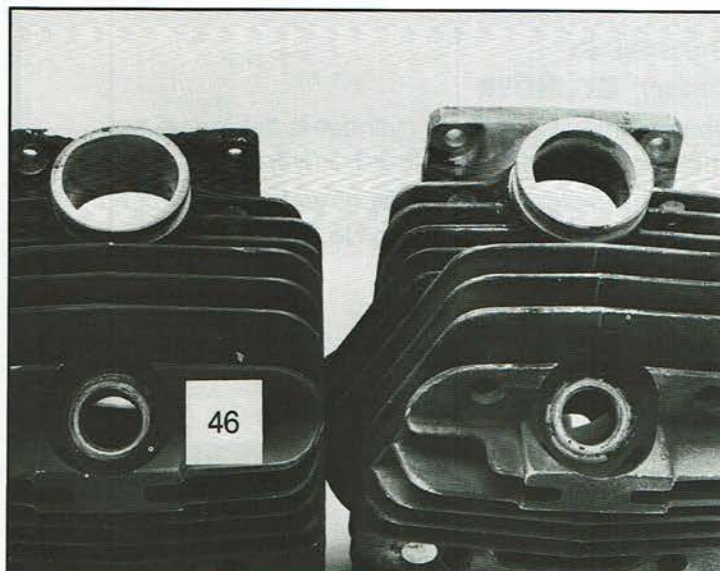
Photo No. 46

Subject: **CYLINDERS INTAKE PORT VIEW**

Observation: Cylinder on the left has a larger intake port.

Cause: Cylinders are the same, the one on the left has been modified by enlarging the intake port. This has caused an overloading of the engine and shortened the life of this engine. This type of modification voids the engine warranty.

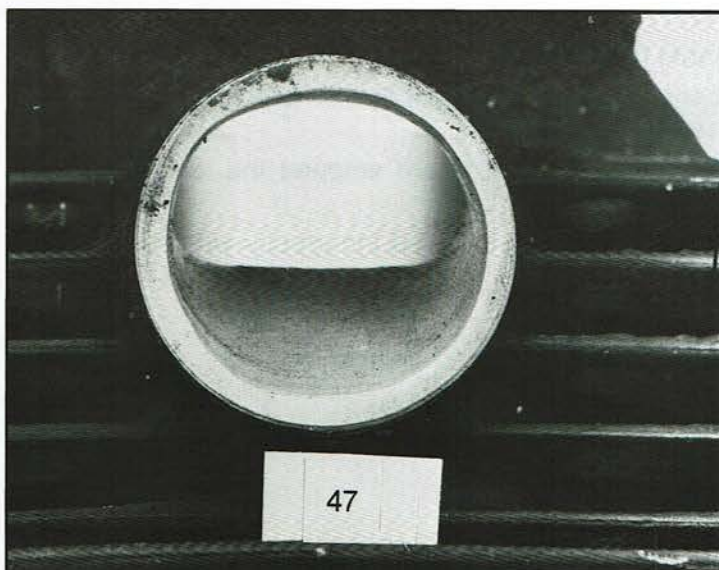
Photo No. 47

Subject: **CYLINDER INTAKE PORT**

Observation: Close-up of modified cylinder in photo No. 46.

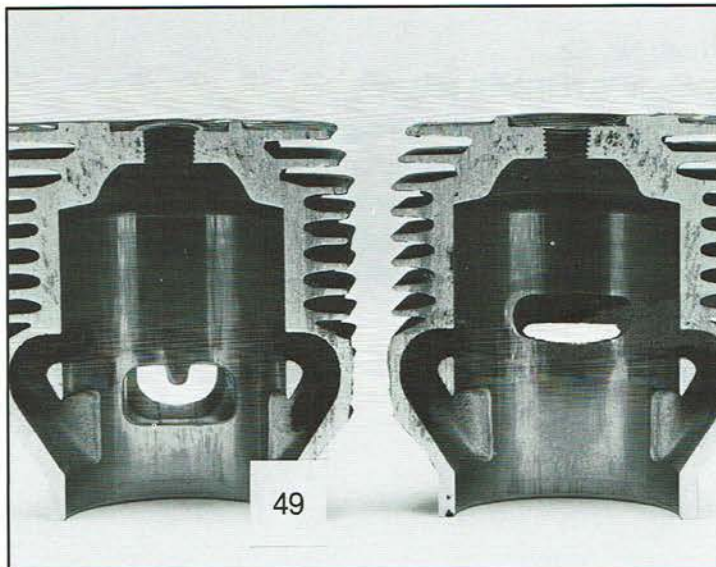
Photo No. 49

**Subject:** BISECTED CYLINDER FOR A PISTON PORTED ENGINE

**Observation:** Note the dirt build-up in the transfer ports and the dirt and carbon crusting in the combustion chamber.

**Cause:** Poor maintenance of the air filter and/or fuel/oil mix and fuel/oil ratio.

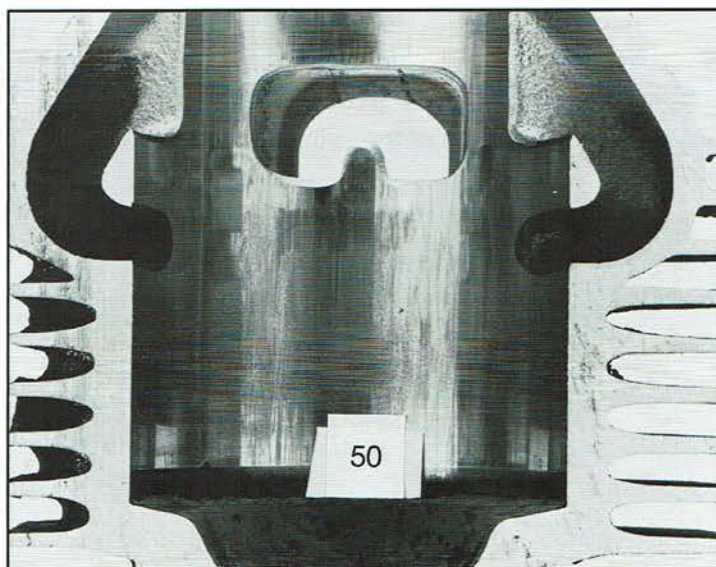
Photo No. 50

**Subject:** CYLINDER HALF

**Observation:** Close-up of the intake port half of cylinder in photo No. 49. Inverted view.

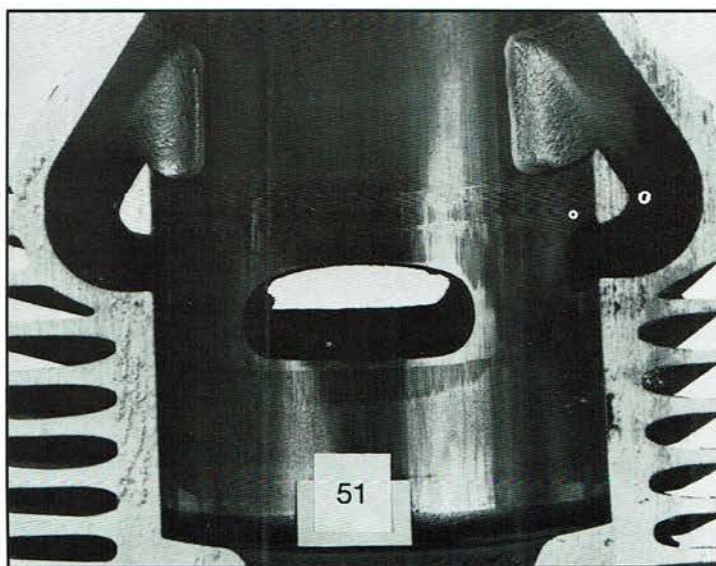
Photo No. 51

**Subject:** CYLINDER HALF

**Observation:** Close up of the exhaust half of the cylinder in photo No. 49. Inverted view.

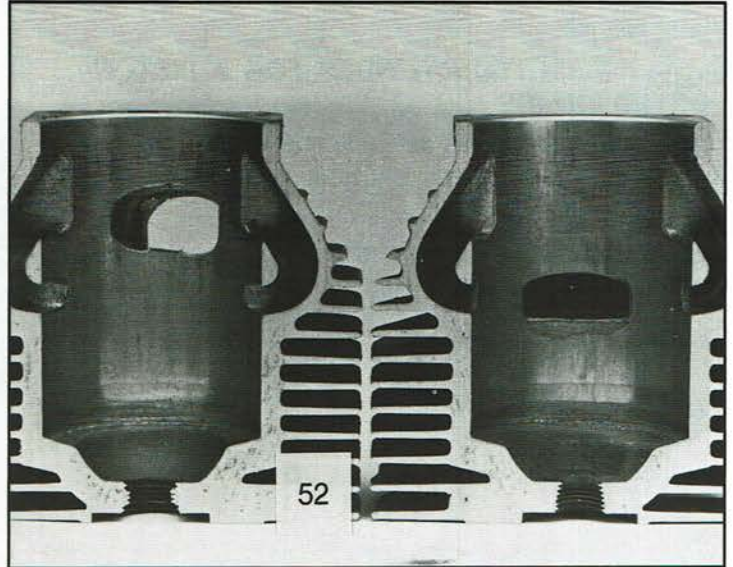
Photo No. 52

Subject: **CYLINDER HALVES**

Observation: Cylinder has damage to the cylinder wall in the area of the exhaust port, as well as scratches above and below intake port.

Cause: Engine has ingested a lot of abrasive dirt. The piston wore to the point of breaking up in the cylinder.

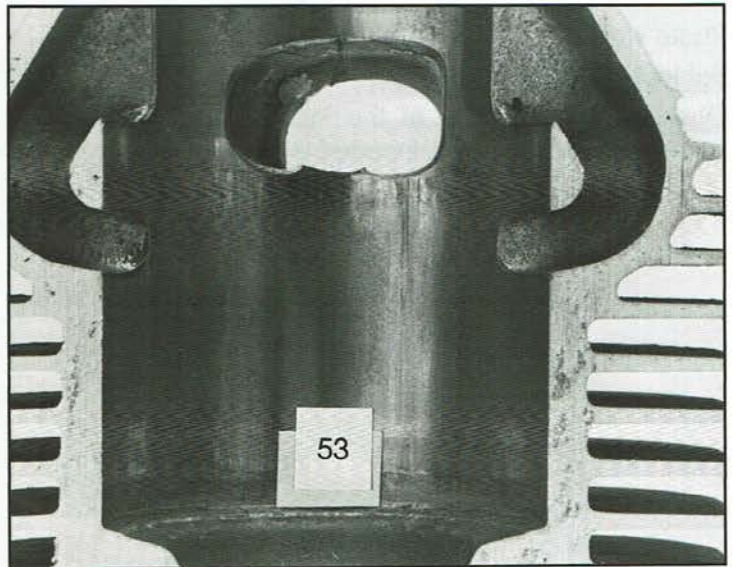
Photo No. 53

Subject: **CYLINDER HALF INTAKE PORT**

Observation: Close-up of the cylinder half in photo No. 52.

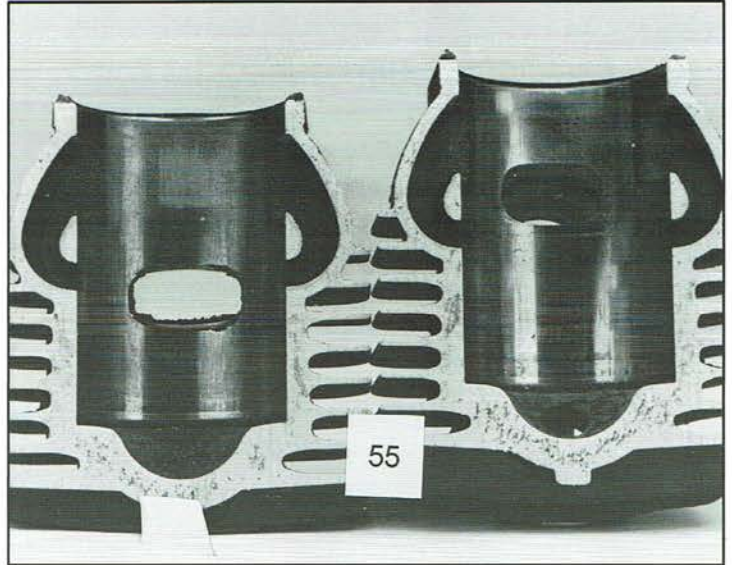
Photo No. 55

Subject: **CYLINDER HALVES**

Observation: Heavy burnishing on the cylinder walls, dirt build-up in the transfer ports and in the combustion chamber.

Cause: Engine has ingested abrasive dirt.

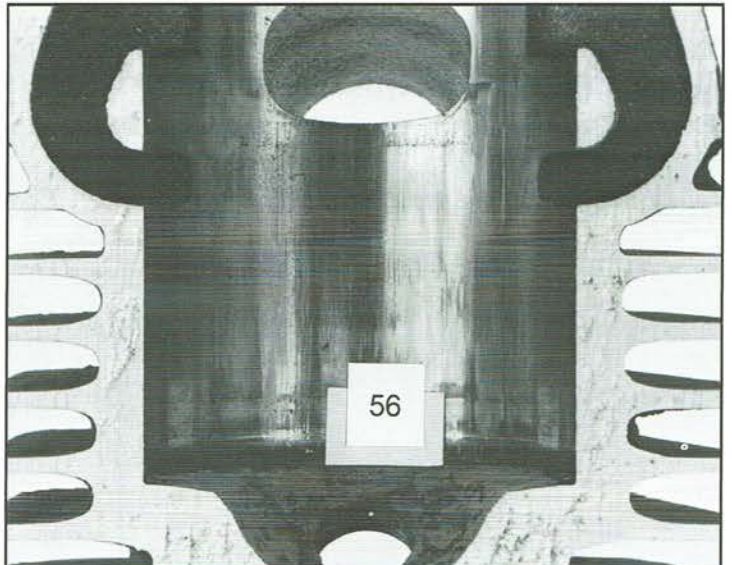
Photo No. 56

Subject: **CYLINDER HALF INTAKE SIDE**

Observation: Heavy burnishing and grinding on the cylinder walls. Build-up of dirt in the transfer ports and combustion chamber. Close-up of photo No. 55.

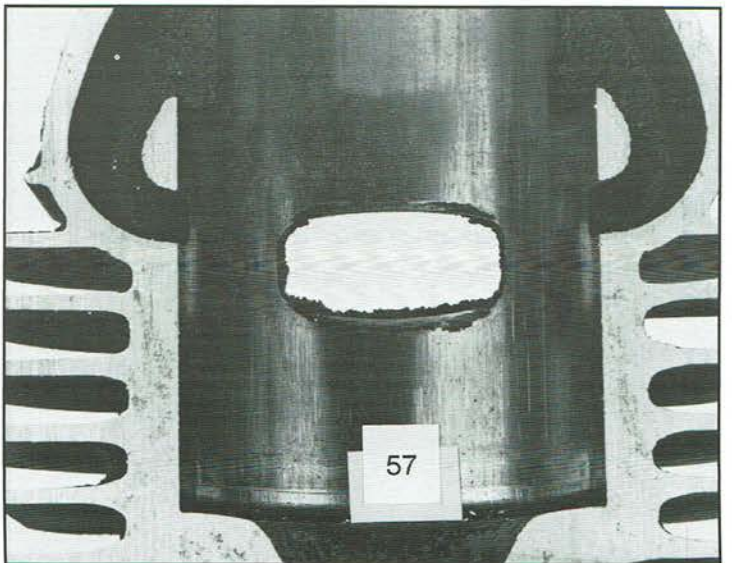
Photo No. 57

Subject: **CYLINDER HALF EXHAUST SIDE**

Observation: Dirt in the transfer ports, pitting and grinding around exhaust port areas and a build-up of dirt in the combustion chamber. Close-up of cylinder in photo No. 55.

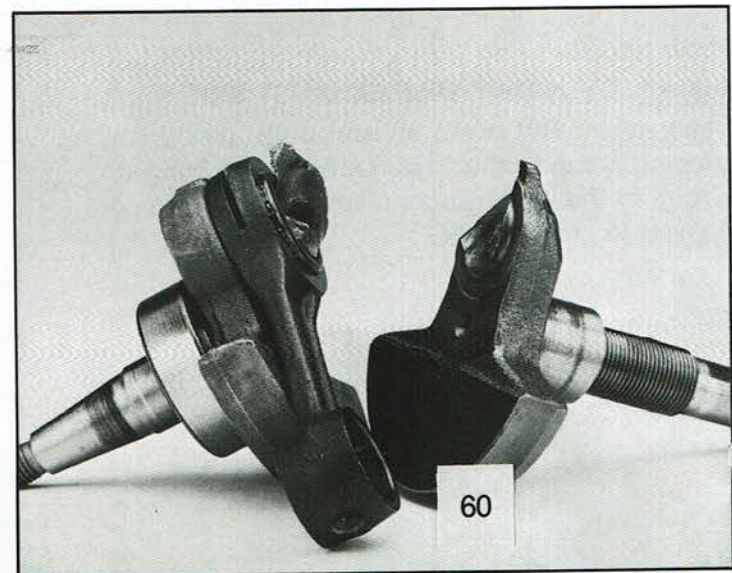
Photo No. 60

Subject: **CRANKSHAFT TWO PIECE TYPE**

Observation: Crankshaft has snapped at the crank pin.

Cause: The engine has been revved beyond its maximum recommended speed the additional force has caused high speed flexing of the crankshaft until it broke.
