**Engine Failure  
Analysis Manual**

# **STIHL ENGINE FAILURE ANALYSIS MANUAL**

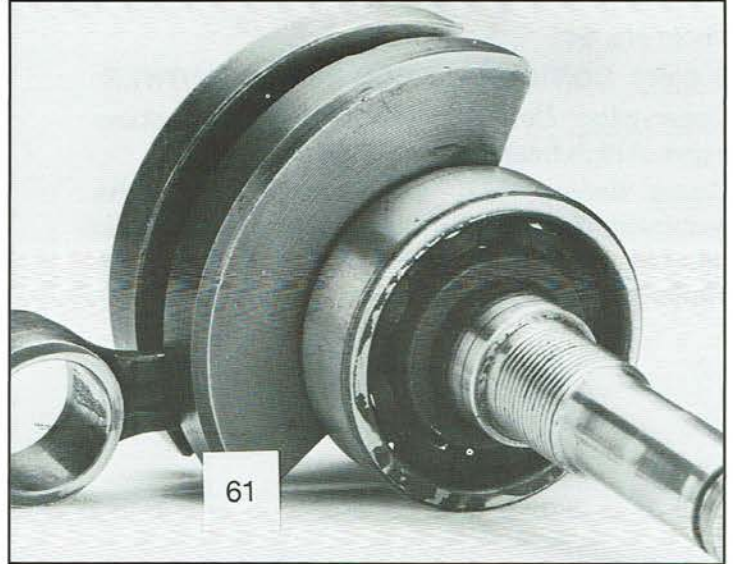
Photo No. 61

Subject: **MAIN BEARING, CONNECTING ROD AND BEARING RACE**

Observation: Bearing is coated with baked on dirt and carbon, bearing surfaces are rough, bearing race surface are pitted.

Cause: Engine has ingested dirt.

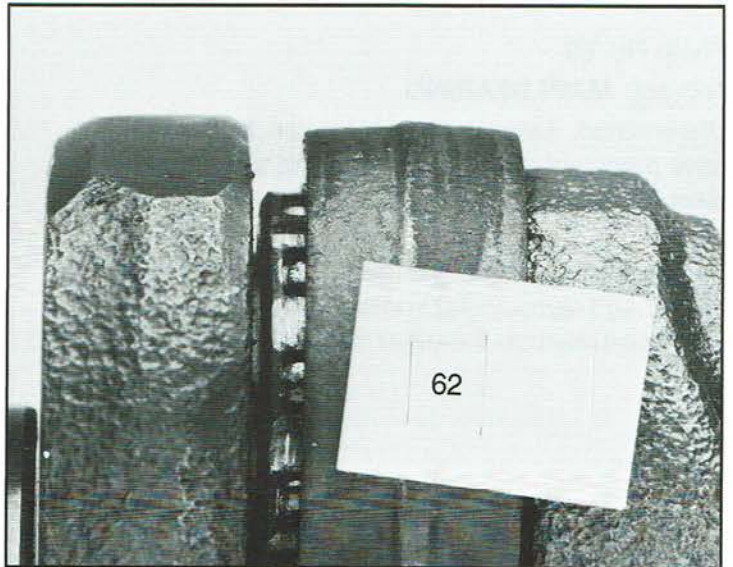
Photo No. 62

Subject: **BEARING LOWER CONNECTING ROD**

Observation: The rod bearing cage is being worn away.

Cause: Dirt ingested into the engine will eventually cause cracking or skidding (flat spots) of the bearings. This causes a build up of heat leads to the failure of the bearing.

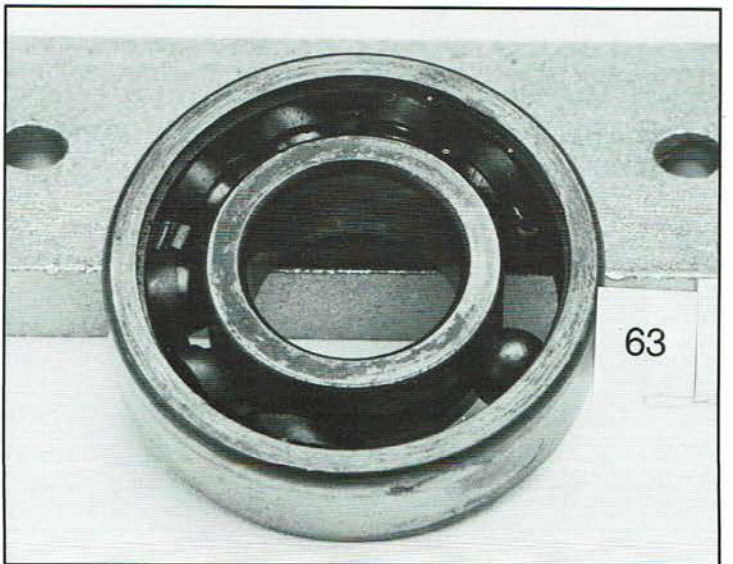
Photo No. 63

Subject: **MAIN BEARING CRANKSHAFT**

Observation: Bearing is darkened from severe heat, cage is distorted.

Cause: Engine has been revved above its maximum recommended speed resulting in overheating and a lubrication breakdown.

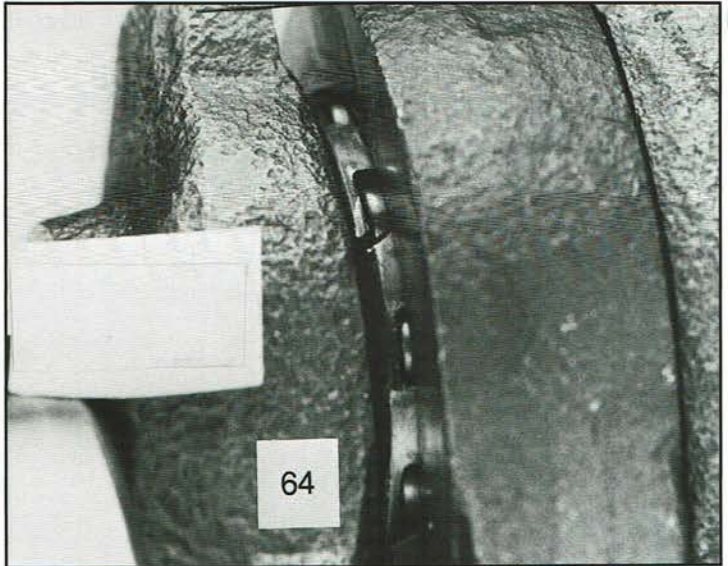
Photo No. 64

Subject: **CONNECTING ROD BEARING, LOWER**

Observation: Connecting rod and stroke pin show signs of high heat. Bearing cage is cracked.

Cause: Engine has been run above the recommended maximum speed. The resulting heat has caused the lubrication to breakdown, cage fracture from load.

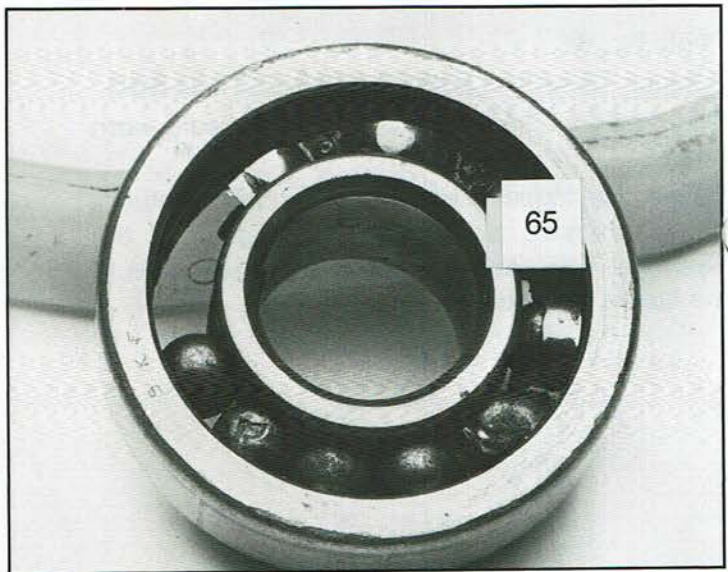
Photo No. 65

Subject: **MAIN BEARING**

Observation: Bearing cage is broken, ball bearings have pieces of material missing and are pitted and have flat spots.

Cause: Engine has been ingesting dirt, the dirt has collected in the bearing races and causes the balls to skid and develop flat spots resulting in heat and increased load on the other balls.

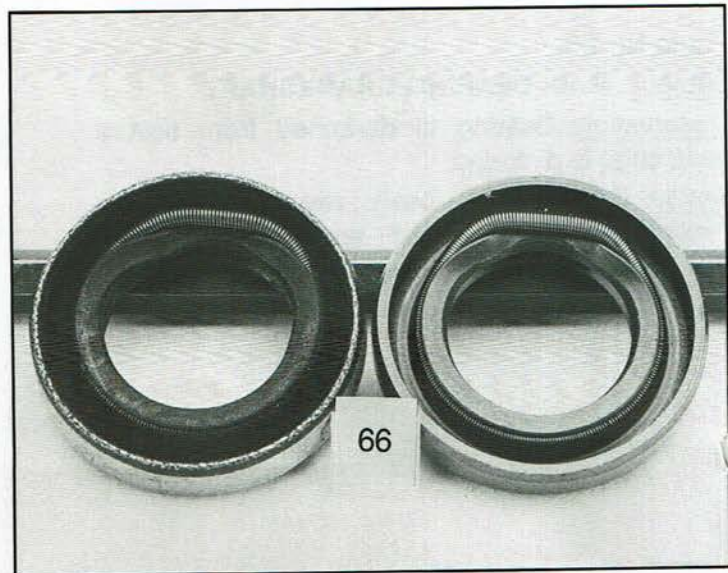
Photo No. 66

Subject: **SEALS**

Observation: Seal on the right is new, seal on the left has been leaking.

Cause: Dirt ingested into the engine will wear the seals away, seal spring damaged or missing.

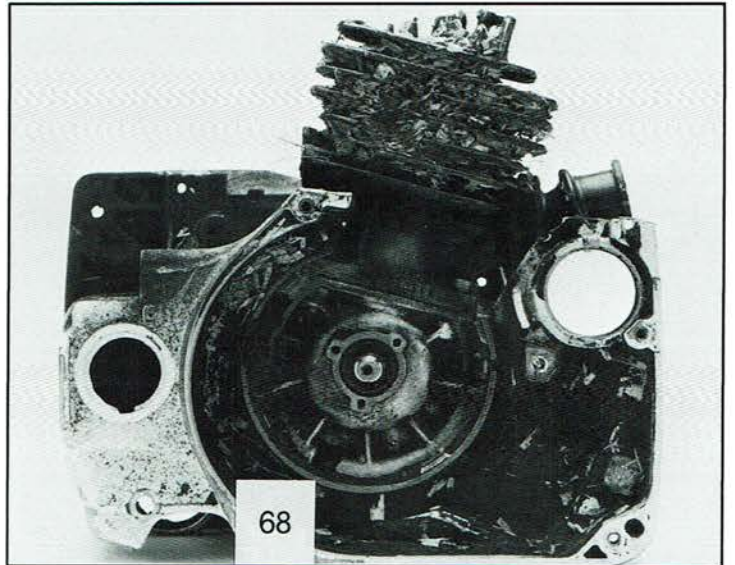
Photo No. 68

Subject: **CRANKCASE WITH CYLINDER**

Observation: Cylinder fins are packed with sawdust and chips.

Cause: Operator has not cleaned saw. This resulted in extreme heat buildup in engine. This causes seized pistons, broken bearings, detonation and lubrication breakdown.
